Visual Tree Assessment Report

Guinea Street
Redcliffe
Bristol
BS1 6SX

CW.240072.R

12th February 2024

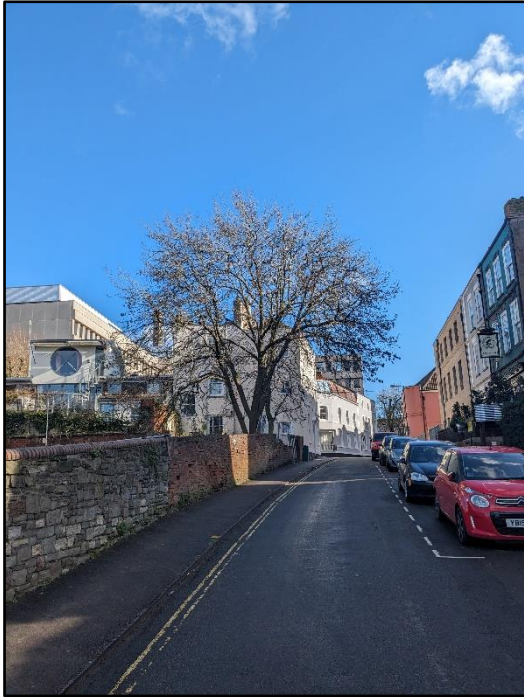
Figure 2: Image showing Ash in landscape viewed from west

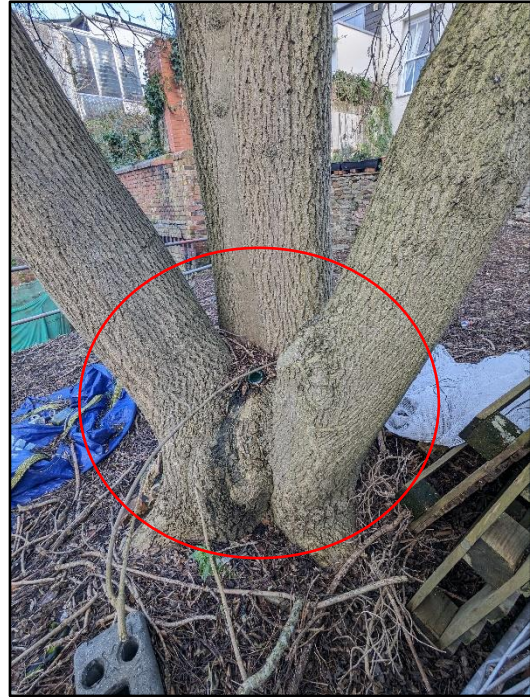
Figure 3: Image showing trifurcated stems

- 5.2.0 I used the International Society of Arboriculture’s (ISA) Tree Risk Assessment methodology, referred to as TRAQ. This is a ‘qualitative’ system which uses a matrix-based combination of ratings, to reach a conclusion of associated risk. More detail can be found in Appendix 1 and Appendix 2 below.
- 5.2.1 Only the dead branches were included within this risk assessment as I judged these to have the greatest likelihood of failure. I do not consider the trifurcated stems or branch unions to be of concern at the present time.

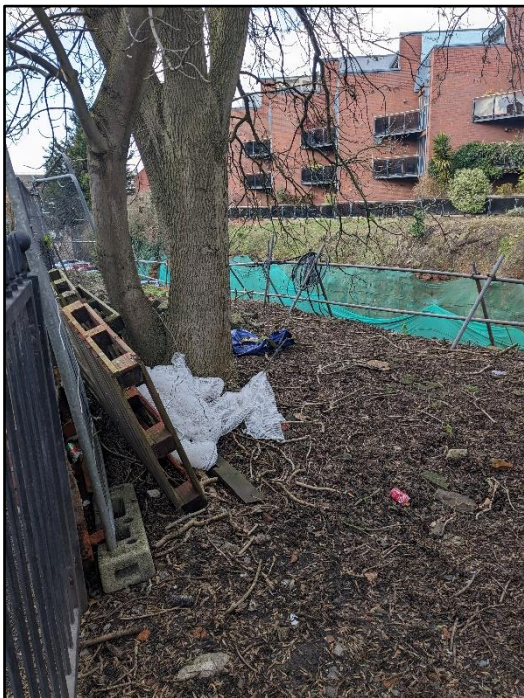
Figure 4: Image showing rooting environment viewed from east and materials piled against tree stem

- 5.1.2 The tree is growing within suspected compacted soil to its northern aspect and pavement over its rooting area to the southern aspect. Despite the ‘poor’ growing environment in which the tree is situated it does not appear to be detrimental to the trees health at present.

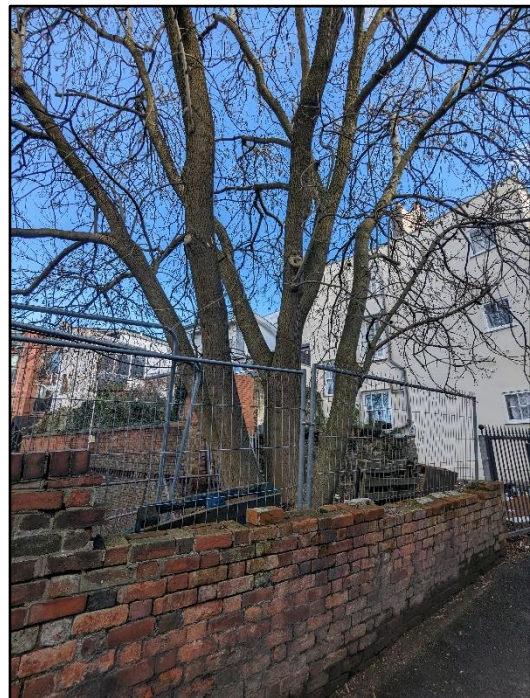
Figure 5: Image showing branching structure of the mid crown viewed from the southwest

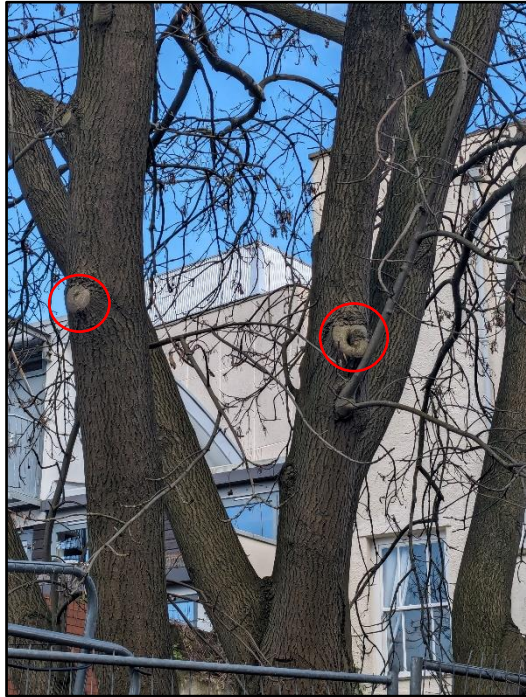
Figure 6: Image showing historic pruning wounds and cavity, southern aspect

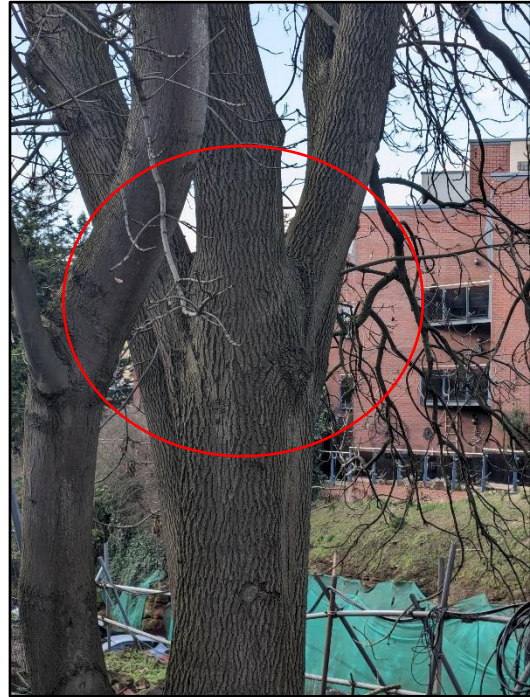
Figure 7: Image showing trifurcated leaders on northern stem

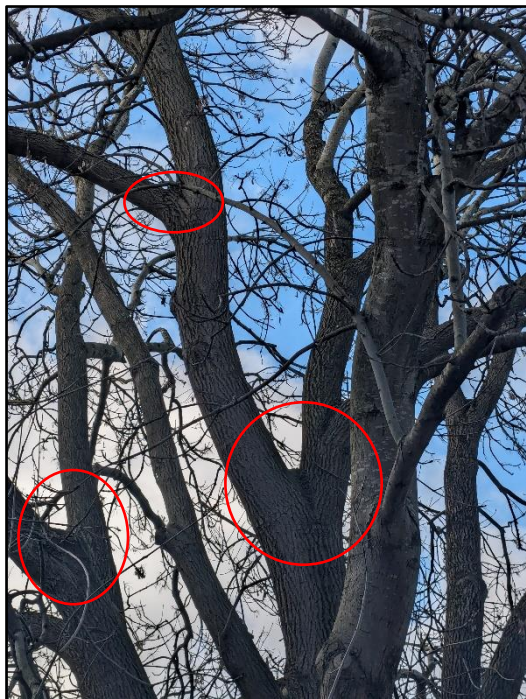
Figure 8: Image showing well-formed branching unions in upper crown

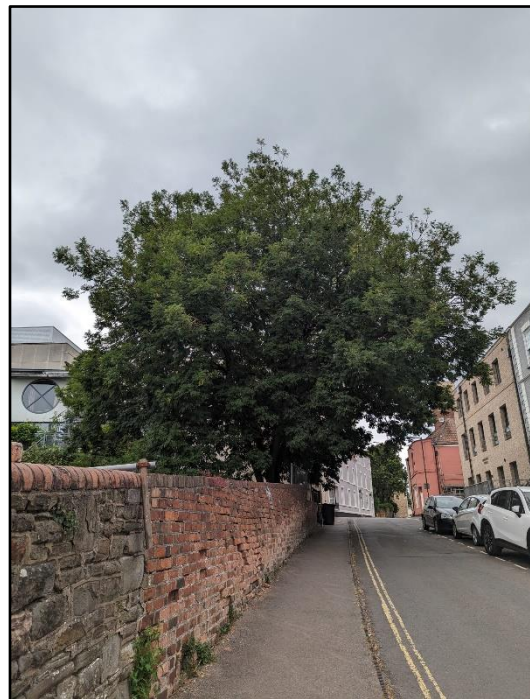
Figure 9: Image provided by Redcliffe West Residents Association of tree in leaf taken 23rd June 2023.

- 5.3.4 A final point to highlight from section 4.2 is that Mr Wright states he was informed “*the foliage of the tree was sparse last year*”. I reference my figure 9 above provided to me by Redcliffe West Resident Association, which I have been advised was taken 23rd June 2023 showing the tree in full leaf, the foliage appears normal and healthy in my opinion.
